DESIGN, FABRICATION AND HYDROTESTING
OF A 120-INCH DIAMETER PRESSURE VESSEL
USING 18 PERCENT NICKEL
MARAGING STEEL

Research Contract Status Report No. 8

LOCKHEED PROPULSION COMPANY
P. O. Box 111
Redlands, California

METALLURGICAL ANALYSIS OF FRACTURED CLOSURE PLATE
OF THE 120-INCH MARAGING STEEL PROTOTYPE VESSEL

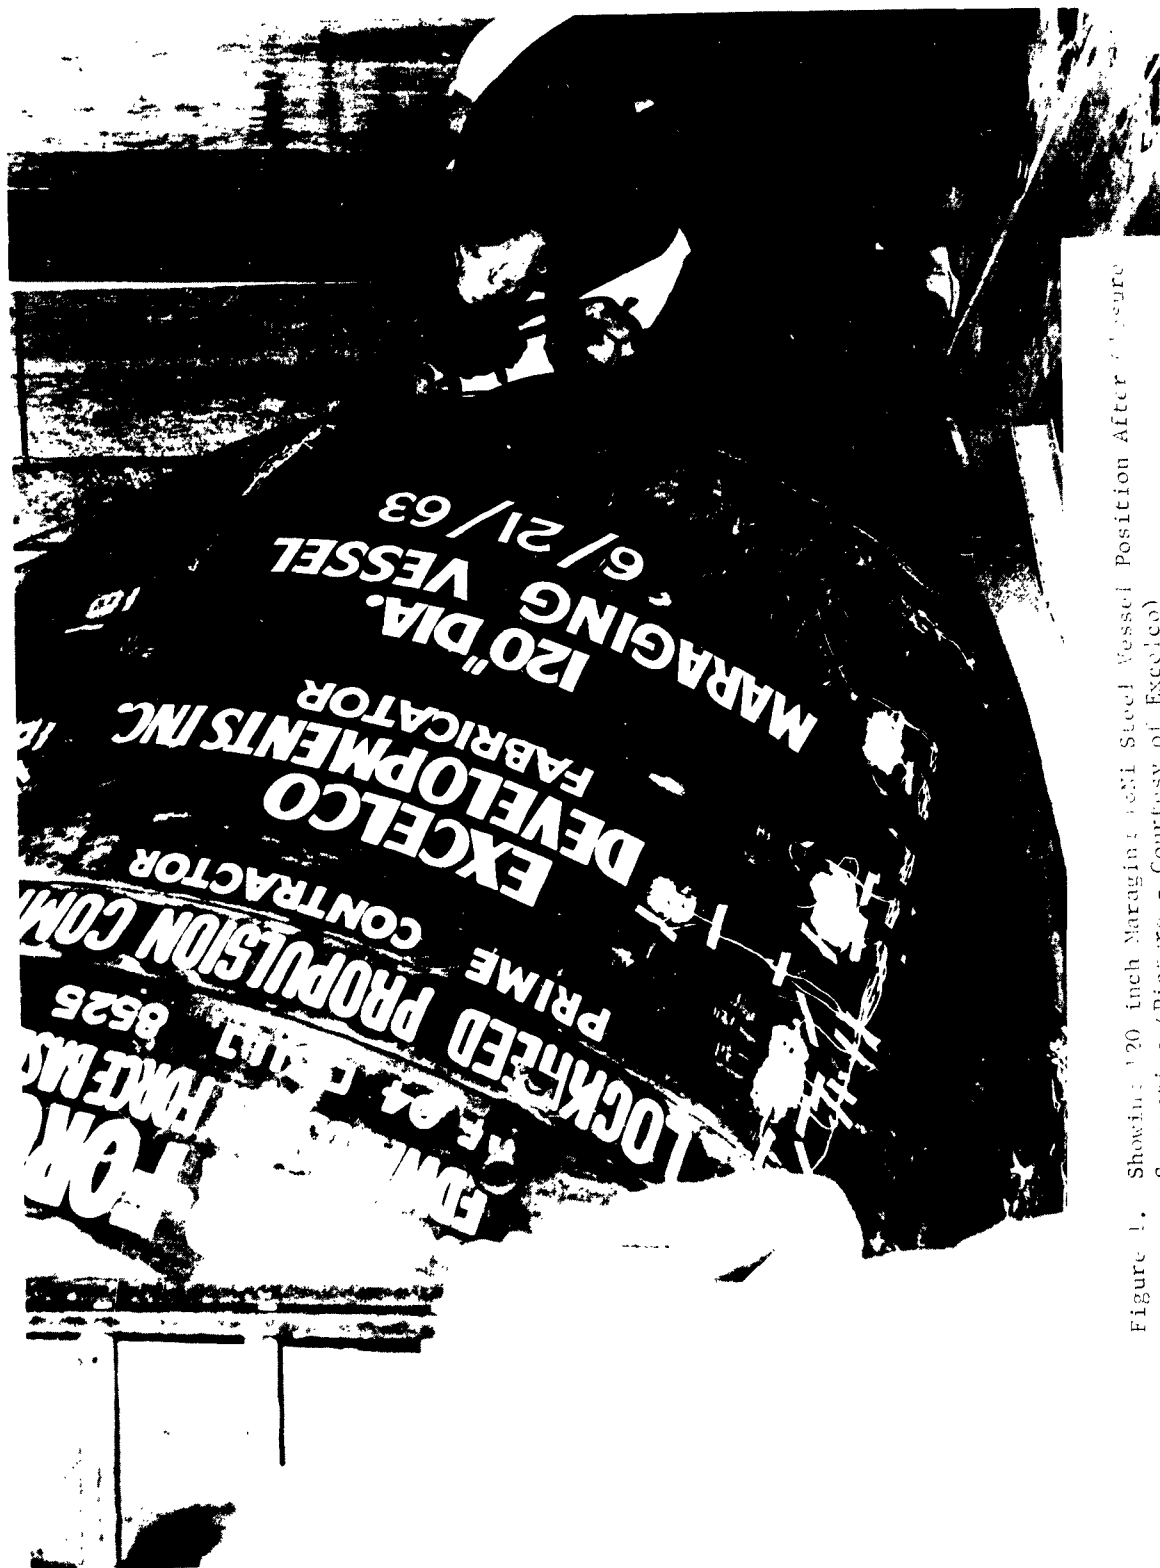
At burst, the closure had been forced down through the steel grating which then hit the concrete pit four feet below. The chamber itself was lying inclined at an angle as shown in Figure 1. The test stand which was supported on steel girders had been driven down with such force that the two 26" beams were badly twisted. The closure plate had broken into several pieces approximately 65 per cent of the main fracture was through the thicker forging. The 5/8" plate welded on to the forging had also fractured and delaminated.

Figure 1. Showing 120 inch Maraging 300 Steel Vessel Position After Pressure Separation (Picture - Courtesy of Excelsco)

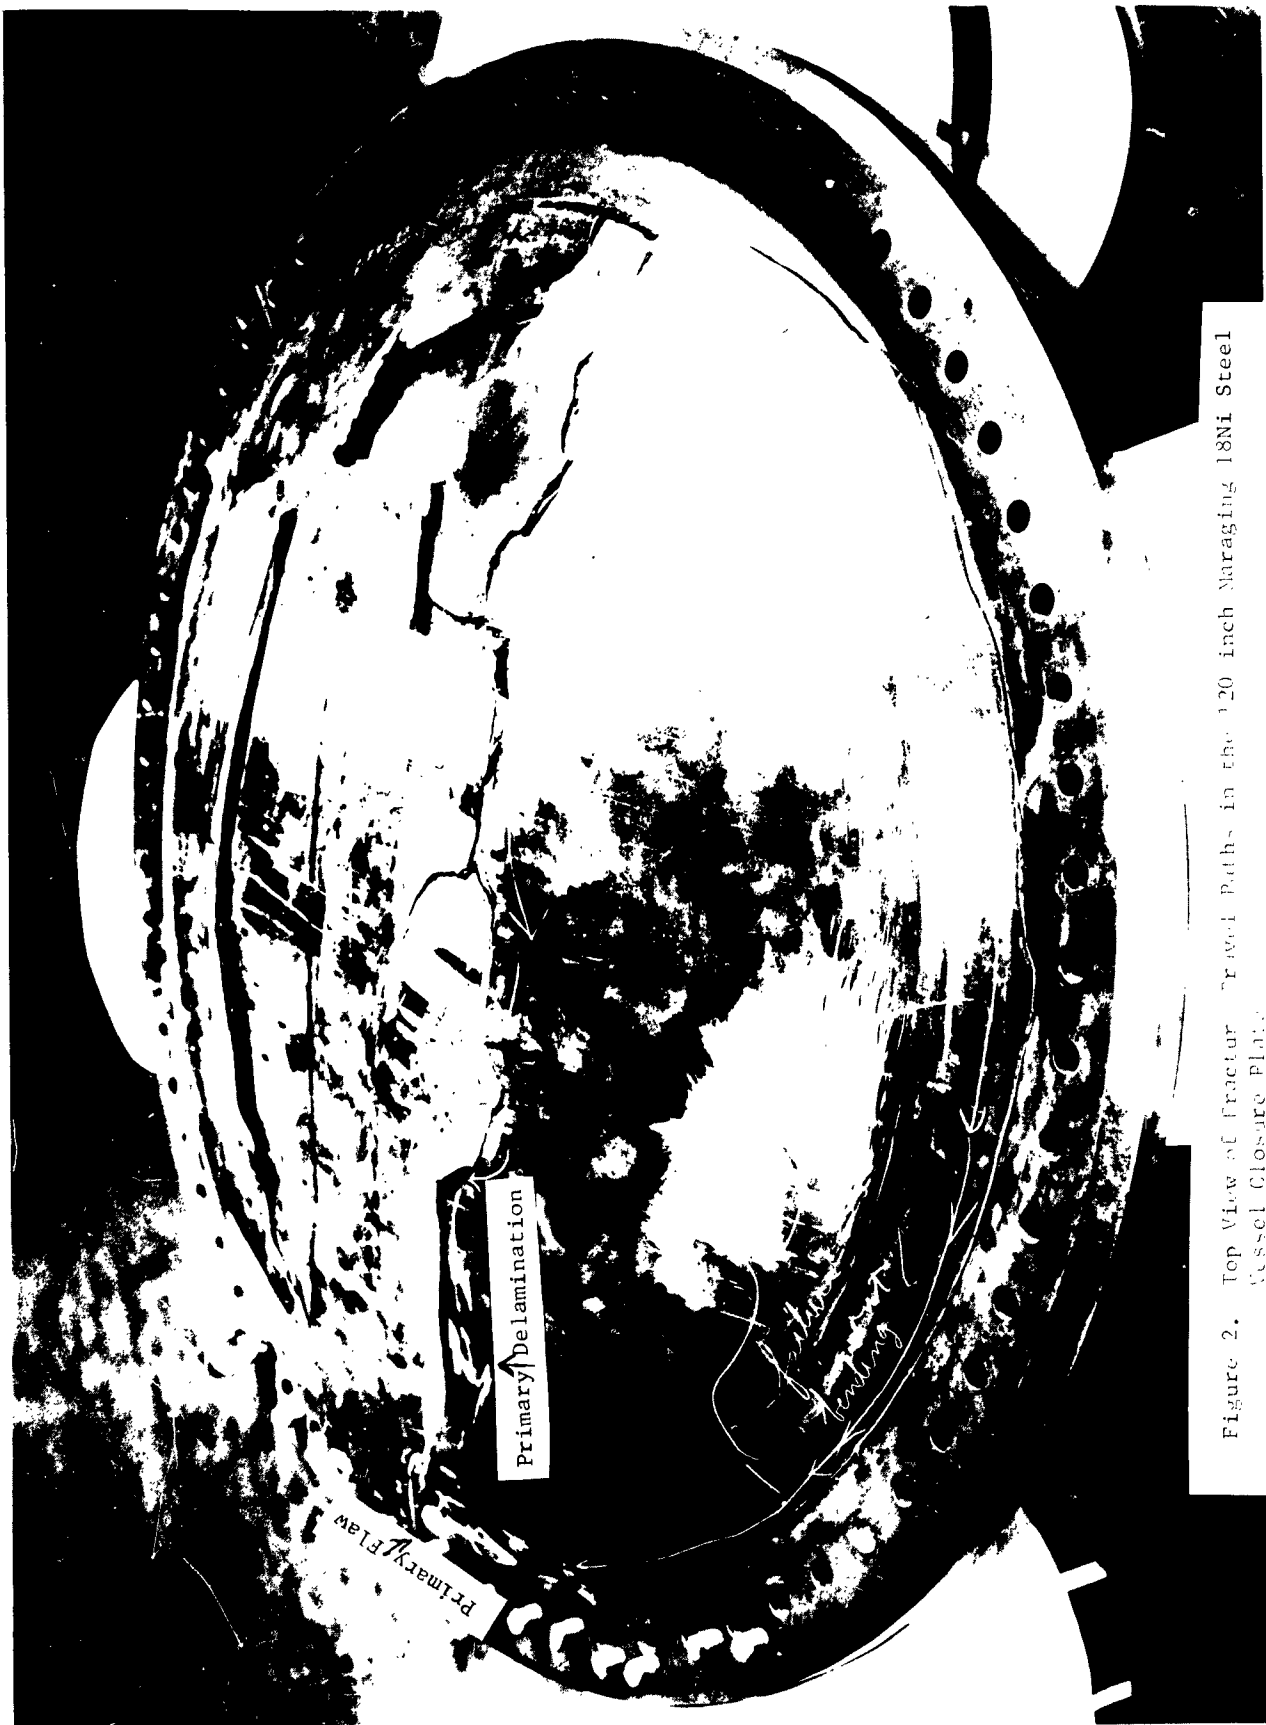
Figure 2. Top View of Fracture Travel Paths in the 120 inch Maraging 18Ni Steel Vessel Closure Plate

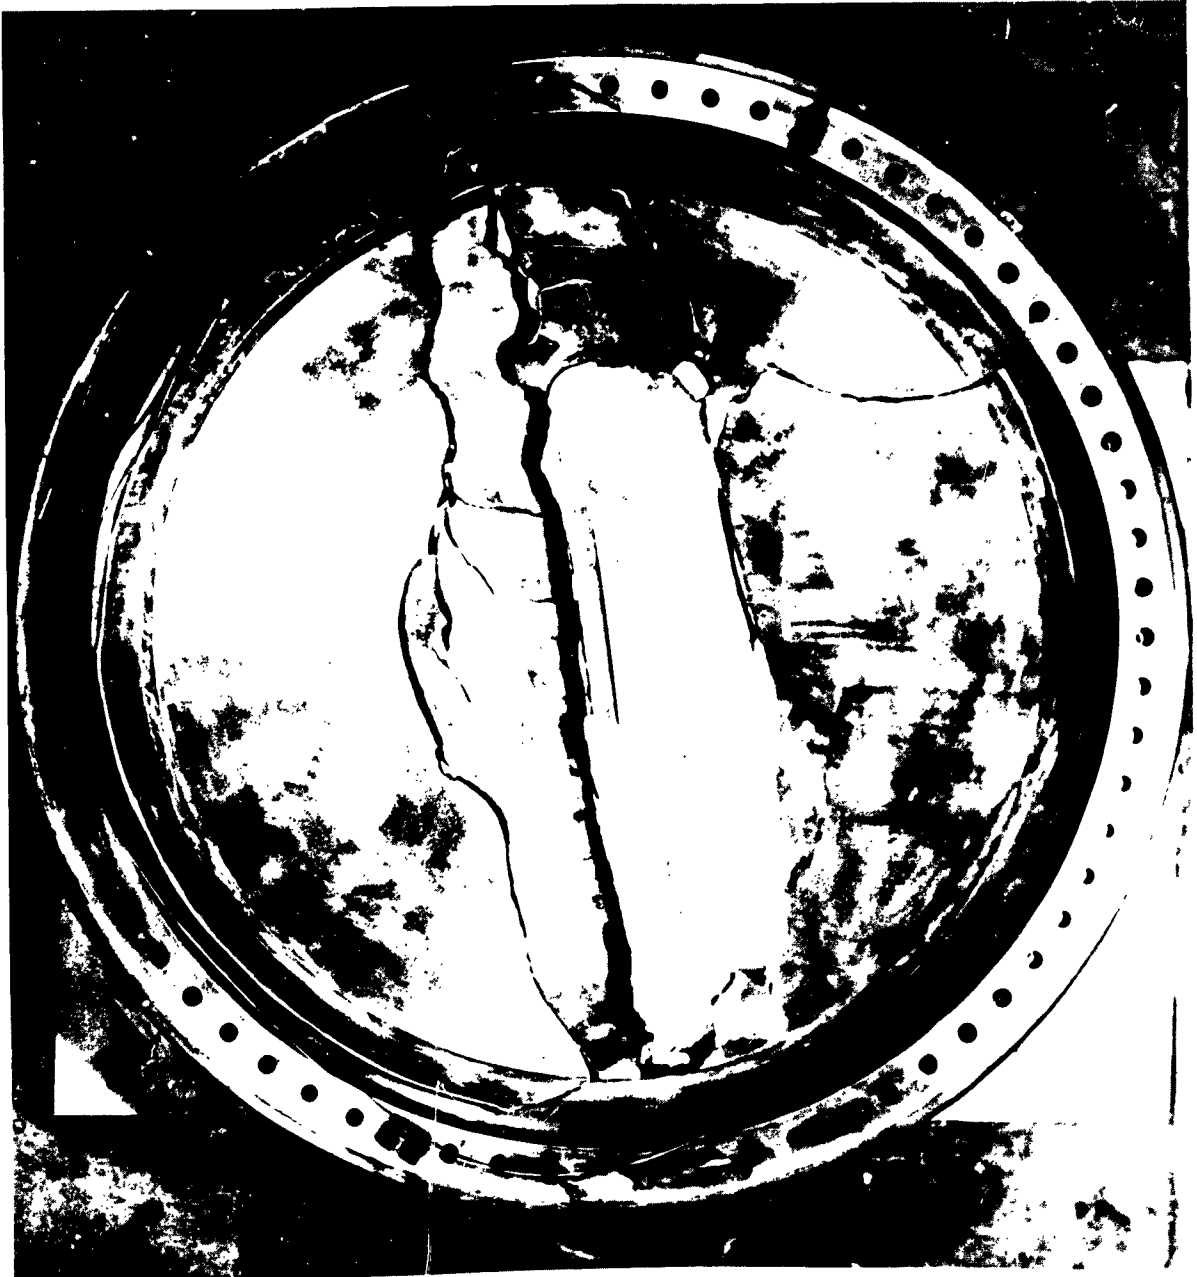
Figure 3. Bottom View of Fracture Travel Paths in the 120 inch Maraging 18Ni Steel Vessel Closure Plate

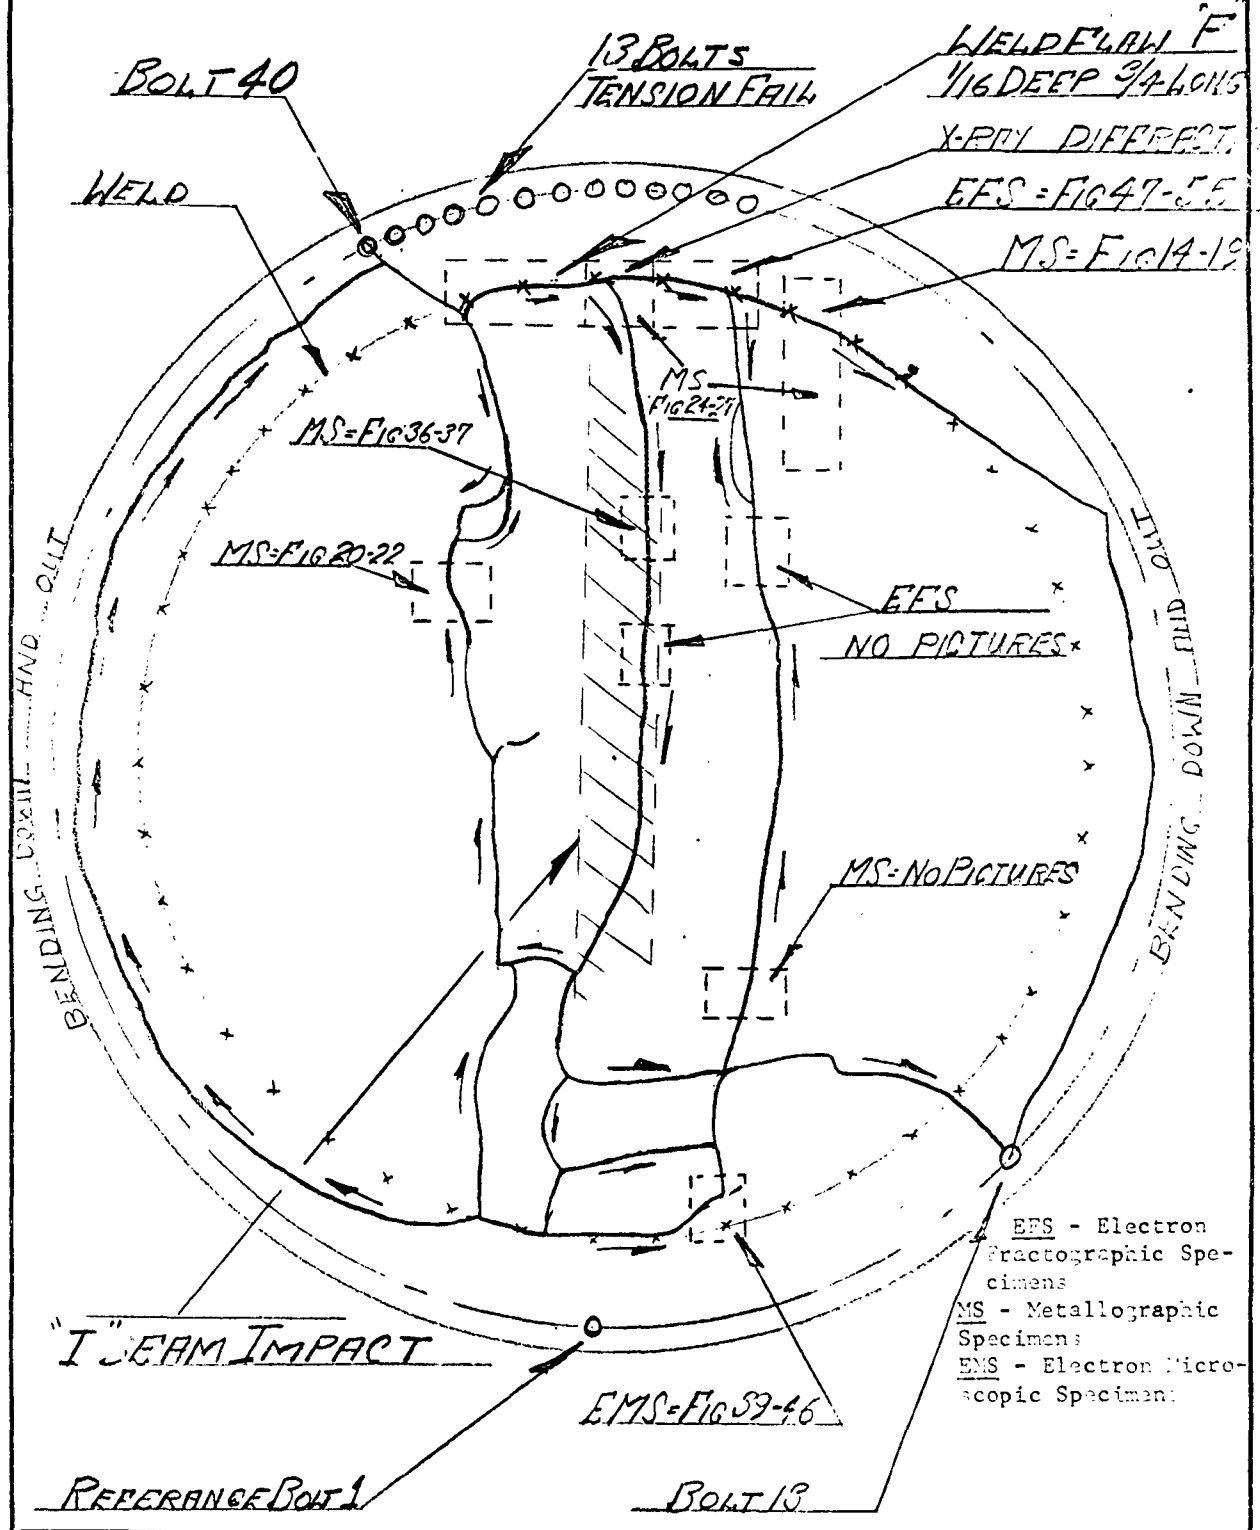
Figure 8 shows the various fracture travel paths and the direction of fracture travel in the closure plate. The fracture paths have cut through the 13th and 40th bolt hole from the reference bolt hole numbered 1. There were no visible defects in the forging although the fracture path had been mostly in the forging. The locations from which the metallographic and fractographic examination specimens were extracted have also been indicated in this figure. The I beam impact area markings on the closure plate have also been traced in Figure 8. Fractures close to this area undoubtedly could have resulted from the impact of the closure plate on the I beam.
